# **BATTLESHIP TEXAS (BB-35)**

## **VESSEL INSPECTION AND ASSESSMENT**

Vessel Survey Report No. 2417

Vessel surveyed at:	La Porte, Texas
Dates of survey:	November - December 2010 January 2011
Vessel surveyed:	Battleship TEXAS (BB-35)
Survey commissioned by:	Texas Parks & Wildlife Battleship TEXAS State Historic Site 3523 Independence Parkway South La Porte, Texas 77571
Purpose of survey:	Vessel Condition Survey

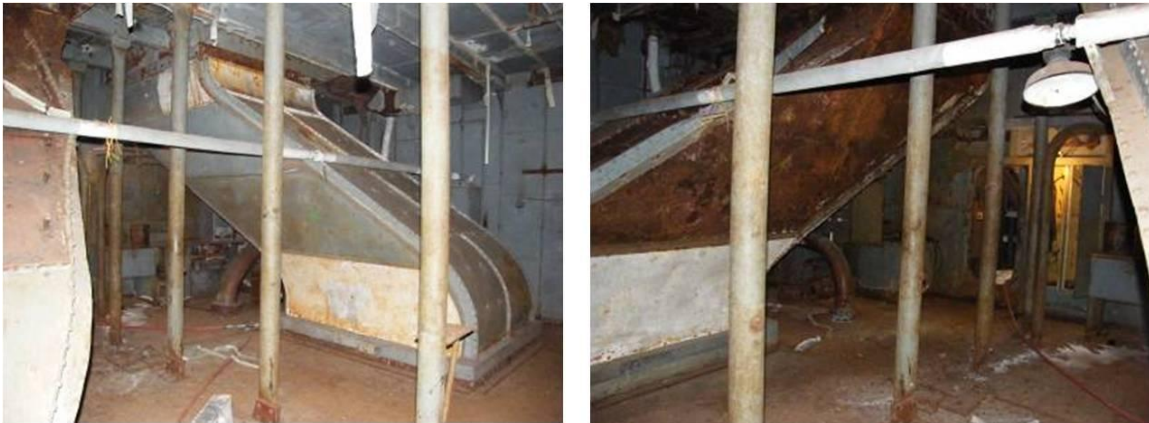
**Figure 232 Drying Room (B-2, Frames NO. 53 – 62; Centerline)**

This space is in good structural and poor/fair cosmetic condition.

**Prepare, prime and paint space.**

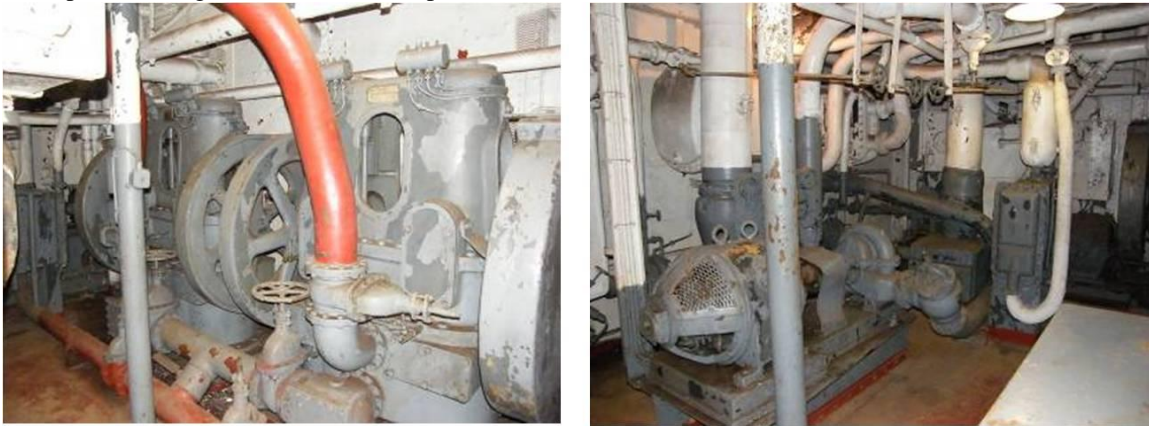
**Figure 236 Evaporator Room (C-100, Frames NO. 76 – 94; Centerline)**

This space is in good structural and poor/fair cosmetic condition.

**Prepare, prime and paint space.**

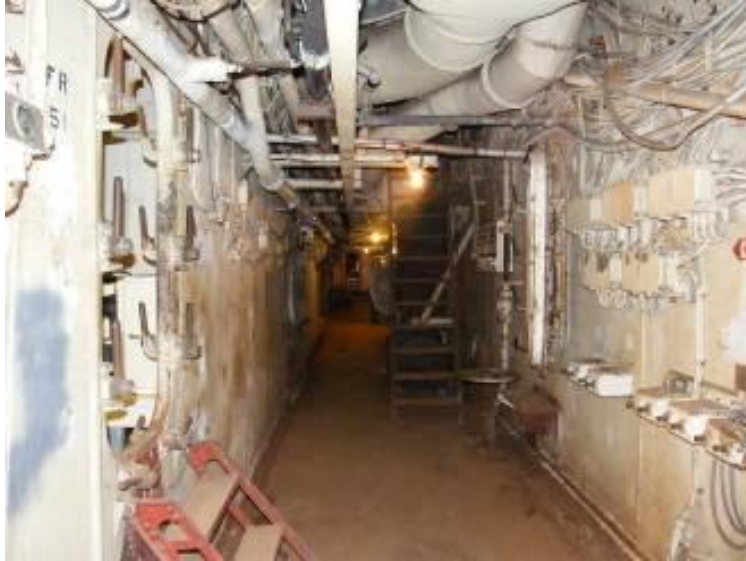
**Figure 237 Ammunition Passage (B-100; Port)**

This space is in good structural and poor/fair cosmetic condition.

**Prepare, prime and paint space.**

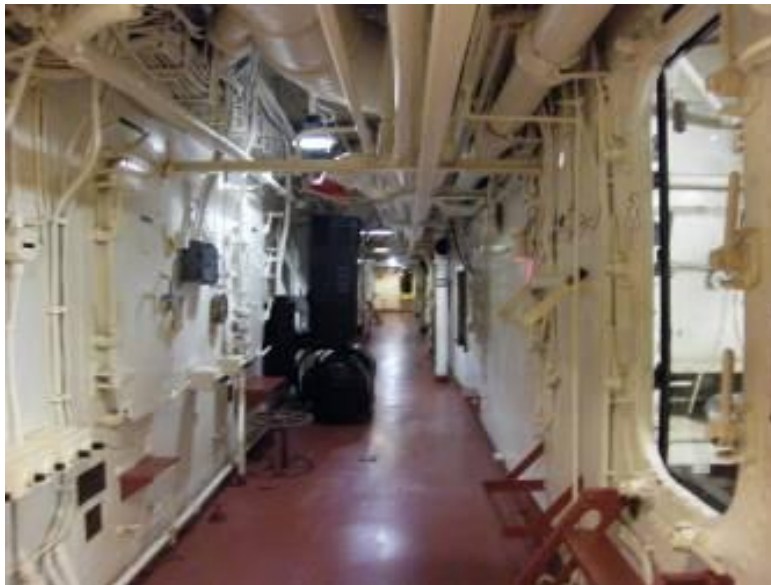
**Figure 238 Ammunition Passageway (B-101; Starboard)**

This space is in good structural and good cosmetic condition.

**Prepare, prime and paint space as needed.**

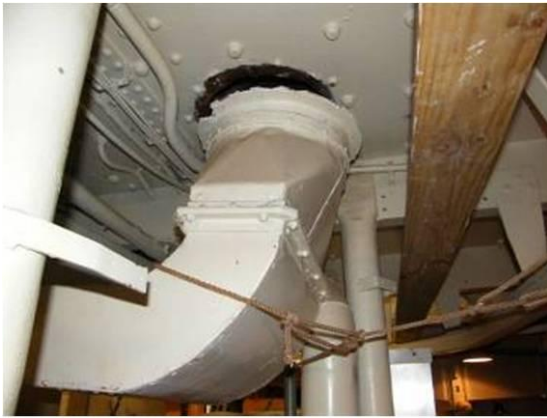
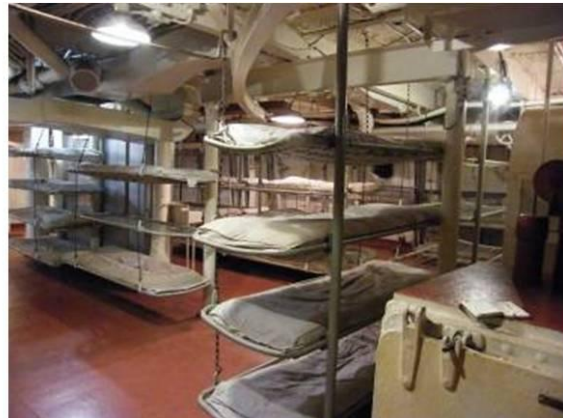
**Figure 240 Carpenter Shop (C-102)**

This space is in good structural and good cosmetic condition. The vent is detached from overhead.

**Repair wasted vent on overhead.**

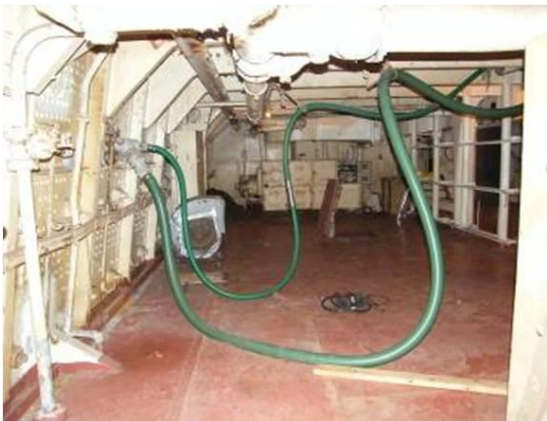
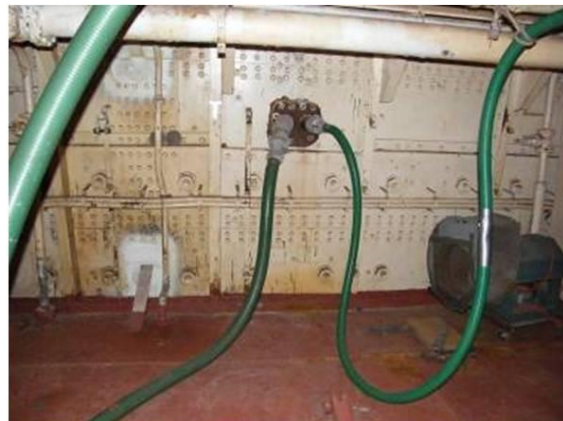
**Figure 241 Crew Space (C-101)**

This space is in good structural and fair cosmetic condition.

**Prepare, prime and paint space.**

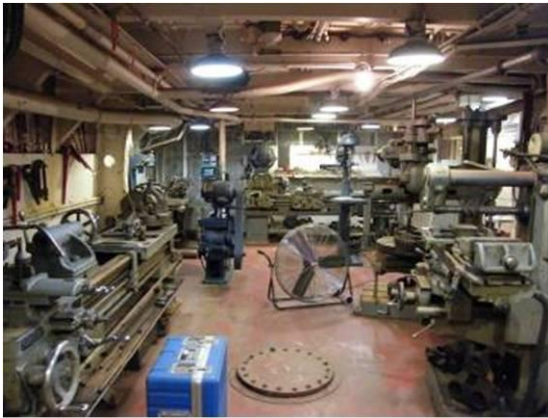
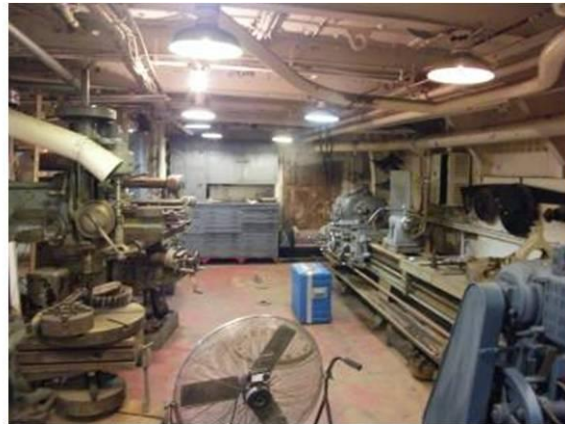
**Figure 242 Machine Shop (C-105; Starboard)**

This space is in good structural and fair cosmetic condition.

**Prepare, prime and paint space.**

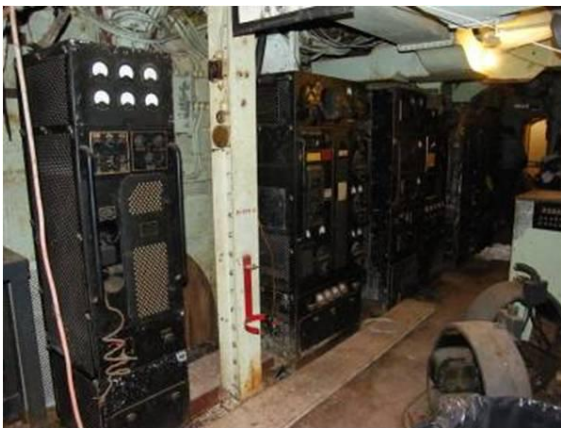
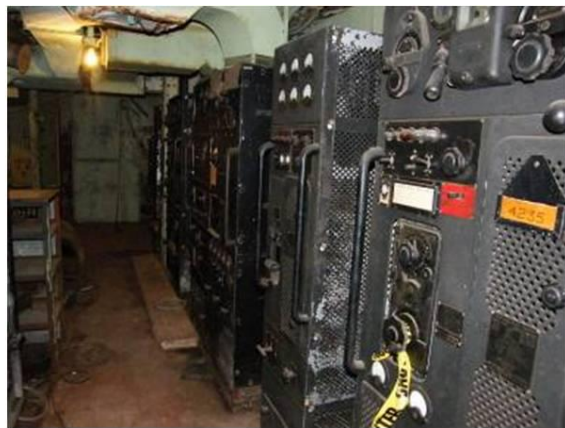
**Figure 243 Radio Transmitter Room (C-103; Centerline)**

This space is in good structural and fair cosmetic condition.

**Prepare, prime and paint space.**

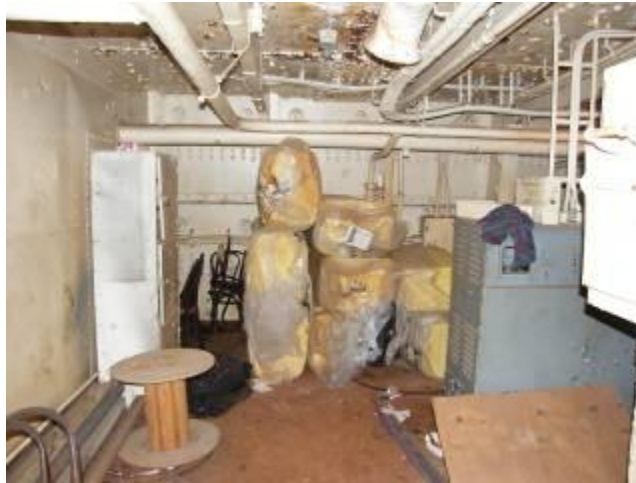
**Figure 244 Crew Space (C-104; Port)**

This space is in good structural and fair cosmetic condition and is presently being utilized as a storage area.

<b>Prepare, prime and paint space.</b>
--

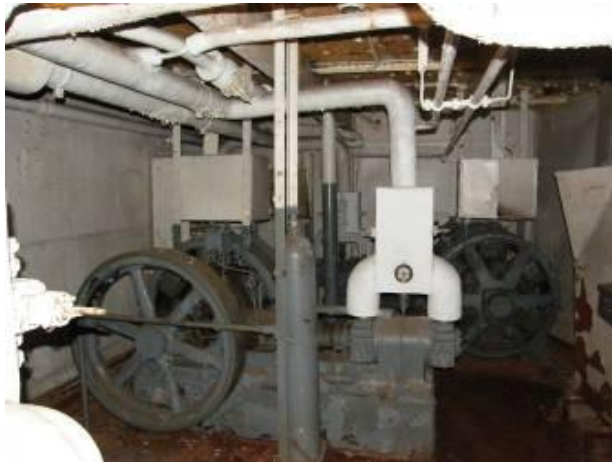
**Figure 245 Ice Machinery Room (C-107; Port)**

This space is in good structural and fair cosmetic condition and is presently being utilized as a storage area.

<b>Prepare, prime and paint space.</b>
--

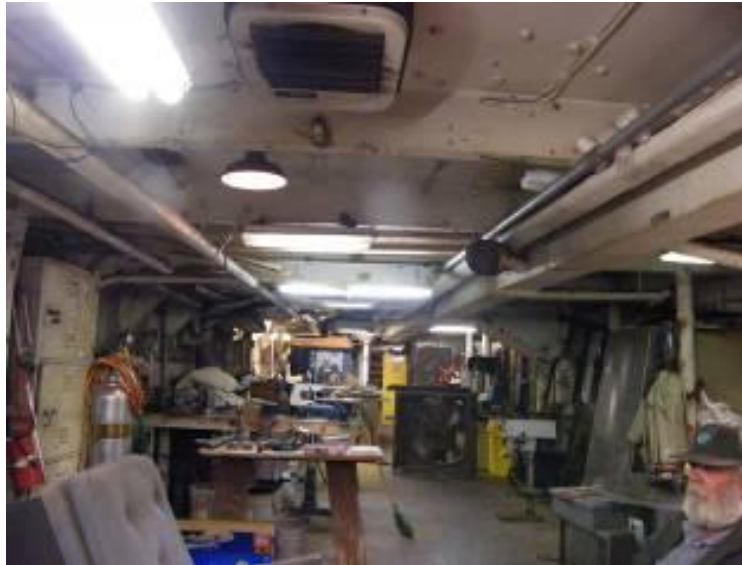
**Figure 246 Crew Space (D-109, Frames No. 104 - 122; Starboard)**

Utilized by the ship's crew as a workshop and a lounge area, this space is in good structural and fair cosmetic condition.

<p><b>Prepare, prime and paint space.</b></p>
---

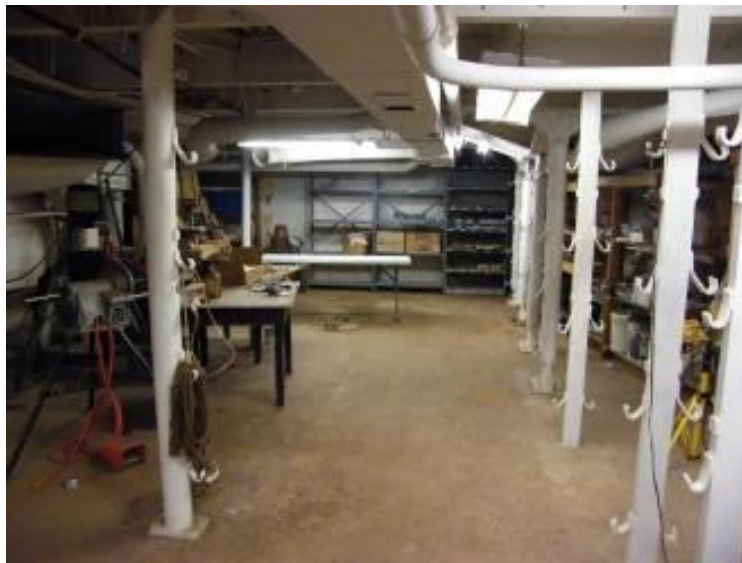
**Figure 247 Crew Space (D-104, Frames No. 104 – 122; Port)**

Utilized by the ship's crew as a workshop and a storage area, this space is in good structural and fair cosmetic condition.

<p><b>Prepare, prime and paint space.</b></p>
---

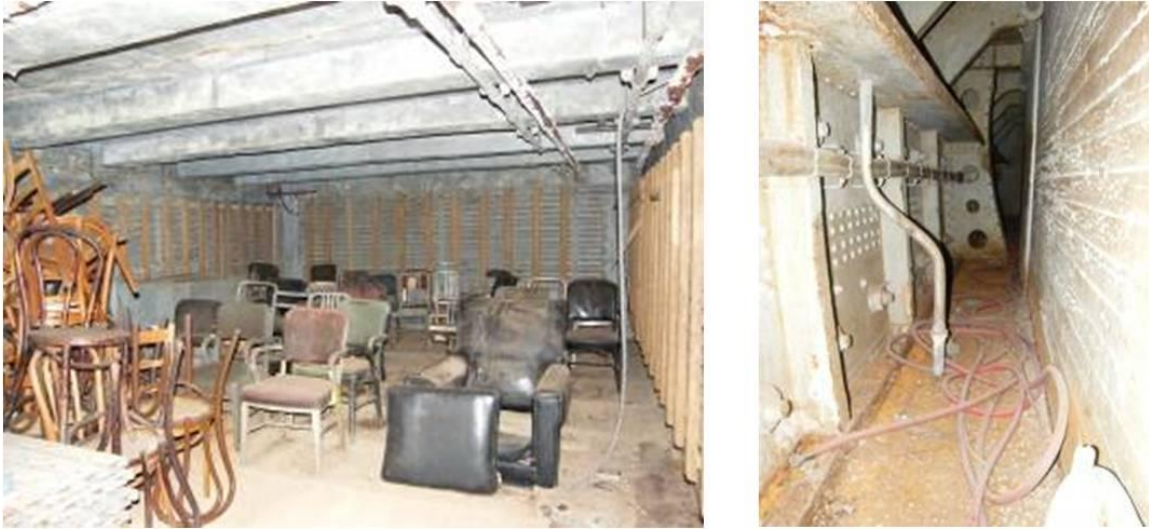
**Figure 248 Area Outside Meat Reefer Room (Against Skin of Ship to Port)**

Utilized by the ship's crew as a workshop and a storage area, this space is in good structural and fair cosmetic condition.

<p><b>Prepare, prime and paint space.</b></p>
---

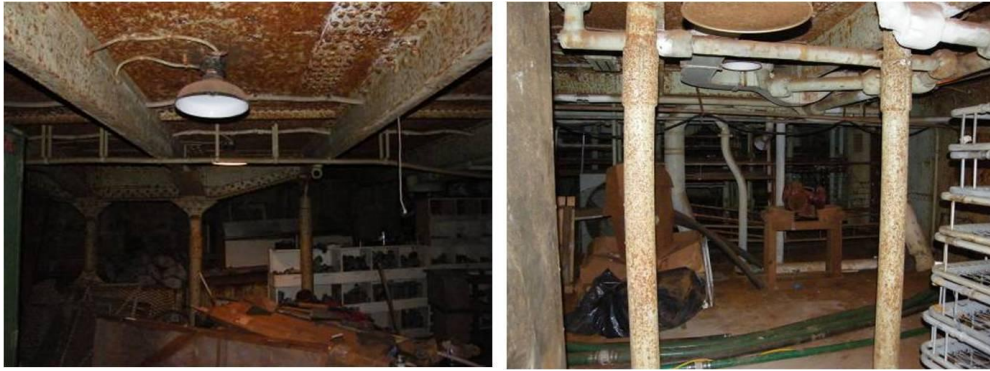
This space is in poor structural and poor cosmetic condition. There is a large amount of rust/scale with a failed paint system.

Structure has failed in that the deck is very thin; outboard tankage has failed with wasted structural scantlings. Inboard vertical stanchions have wasted pedestals and are bending under the load stresses exerted from the spaces above (see Figure 250 and Figure 251).

**Figure 250 CPO Country/Berthing (Looking Forward and Showing Bent Structural Stanchions)**

**Repair/replace vertical stanchions and stanchion pedestal bases as needed to ensure proper support of upper deck.**

**Repair/replace lower 4' of transverse bulkhead fore and aft**

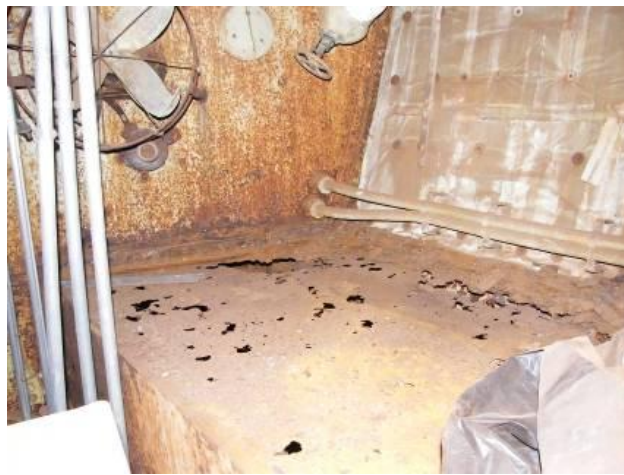
**Figure 251 Wasted Tank Top in CPO Berthing**

**Repair/replace deck as needed to maintain structural integrity with bulkhead and other scantlings.**

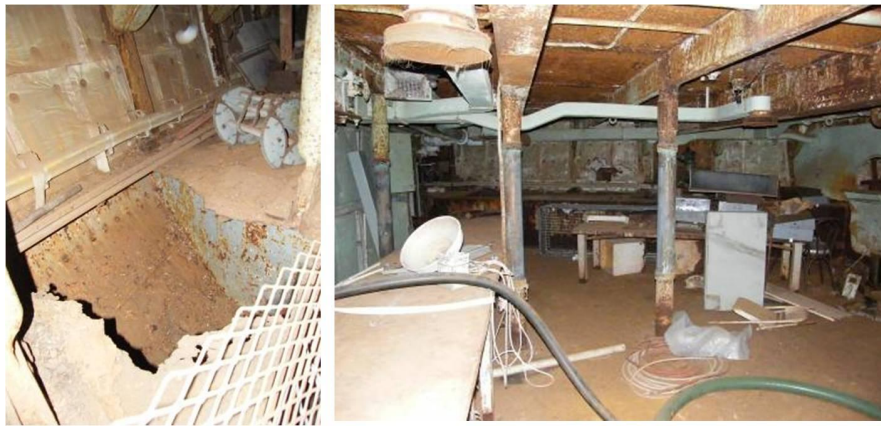
Structure has failed in that the deck is very thin; outboard tankage has failed with wasted structural scantlings. Inboard vertical stanchions have wasted pedestals and are bending under the load stresses exerted from the spaces above

The deck is paper thin (or failed outright) throughout and needs to be replaced as a safety and structural issue. The hatches leading to the pair of voids below have wasted frames/foundations and need to be replaced.

**Figure 252 Wasted Tank Top (Left Panel) and Wasted Stanchions (Right Panel; Looking to Starboard) in CPO Mess**

**Repair/replace deck as needed to maintain structural integrity with bulkhead and other scantlings. Repair outboard tankage as needed to ensure watertight integrity.**

**Repair/replace vertical stanchions and stanchion pedestal bases as needed to ensure proper support of upper deck.**

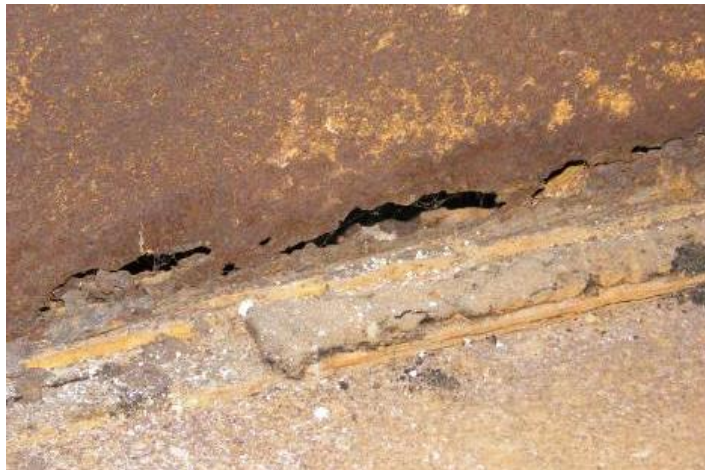
**Figure 253 Wasted Tankage at Deck Line in CPO Mess**

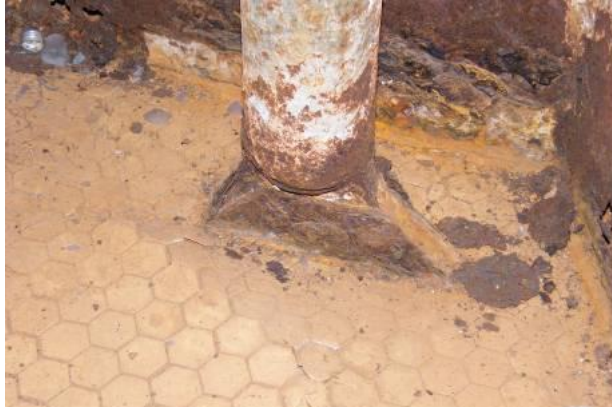
Structure has failed in that the deck is very thin; outboard tankage has failed with wasted structural scantlings. Inboard vertical stanchions have wasted pedestals and are bending under the load stresses exerted from the spaces above

**Figure 255 Wasted Pedestal for Structural Scantling in CPO Pantry (Note Wasted Tank Top Vertical Plating in Background)**

**Repair/replace vertical stanchions and stanchion pedestal bases as needed to ensure proper support of upper deck. Repair/replace lower 4' of transverse bulkhead fore and aft.**

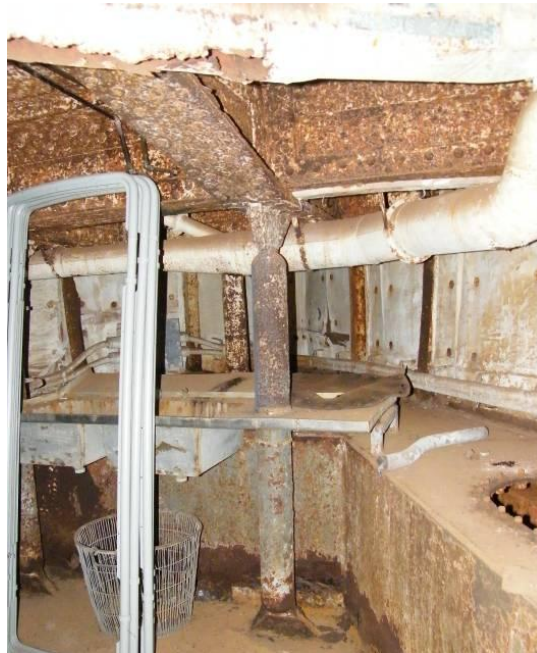
Transverse bulkheads (fore and aft) have failed and are rusted through.

**Figure 256 Looking Aft in CPO Pantry (Notice Stanchions Supporting Heavy Structural Members of Second Deck Above)**

**Repair/replace deck as needed to maintain structural integrity with bulkhead and other scantlings. Repair outboard tankage as needed to ensure watertight integrity.**

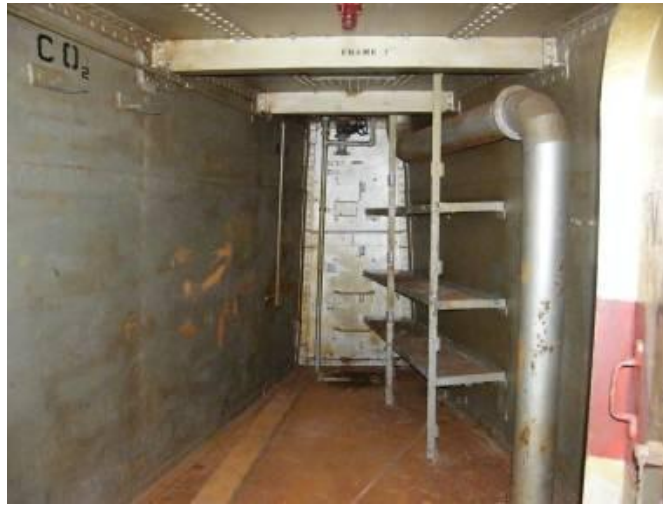
**Figure 258 Oil Room (A-42, Frames No. 5 – 9)**

This space is in good structural and fair cosmetic condition

**Prepare, prime and paint space.**

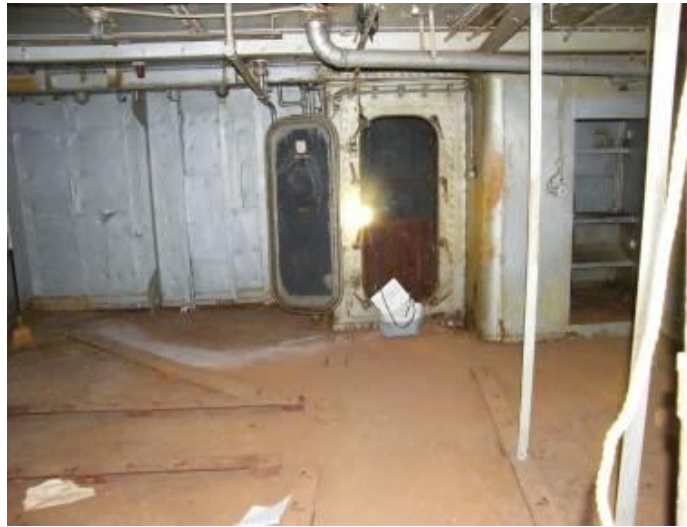
**Figure 259 Paint and Oil Room (A-43, Frames No. 9 - 14)**

This space is in good structural and fair cosmetic condition.

**Prepare, prime and paint space.**

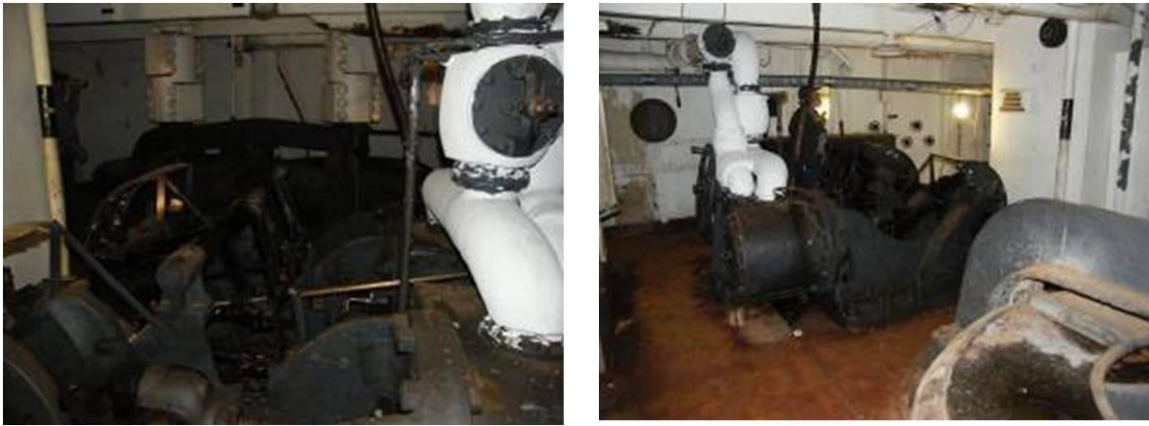
**Figure 260 Windlass Machinery Room (A-47, Frames No. 14 – 24)**

This space is in good structural and fair cosmetic condition.

<b>Prepare, prime and paint space.</b>
--

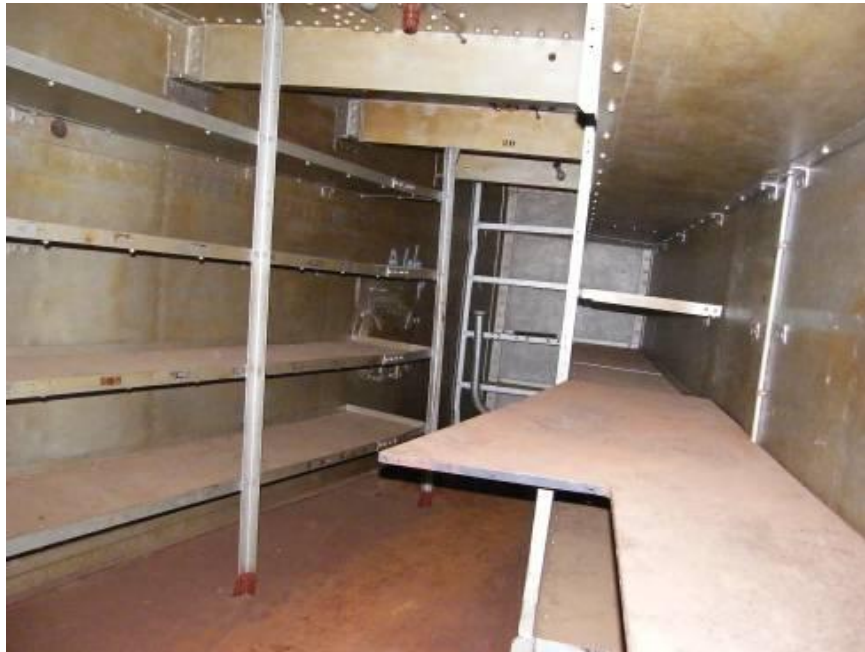
**Figure 261 Navigation Stores (A – 49P)**

This space is in good structural and fair cosmetic condition.

<b>Prepare, prime and paint space.</b>
--

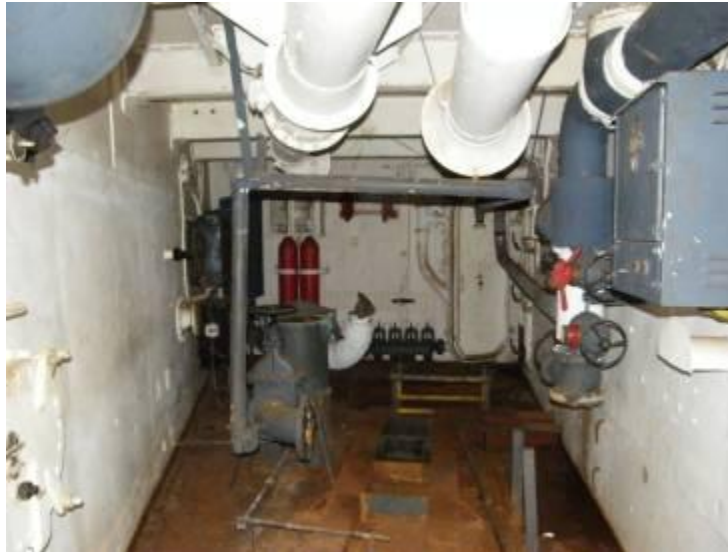
**Figure 262 Pump Room (A – 49S)**

This space is in good structural and fair cosmetic condition.

**Prepare, prime and paint space.**

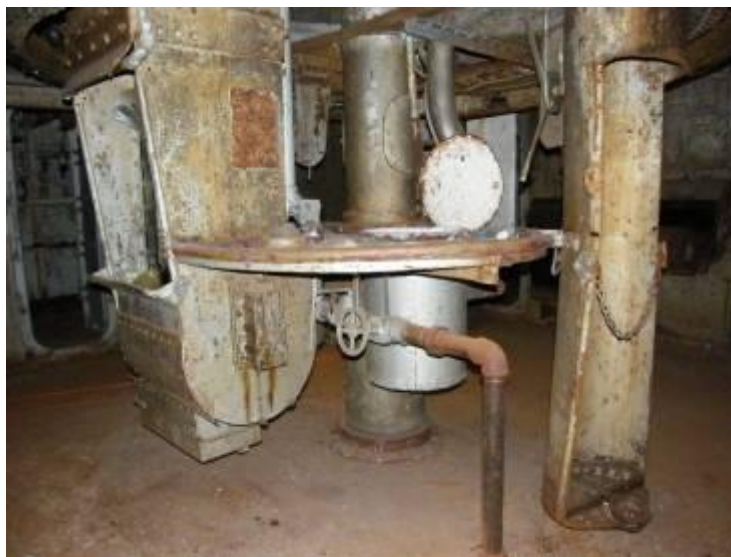
**Figure 263 Handling Room (A – 50)**

This space is in good structural and fair cosmetic condition.

**Prepare, prime and paint space.**

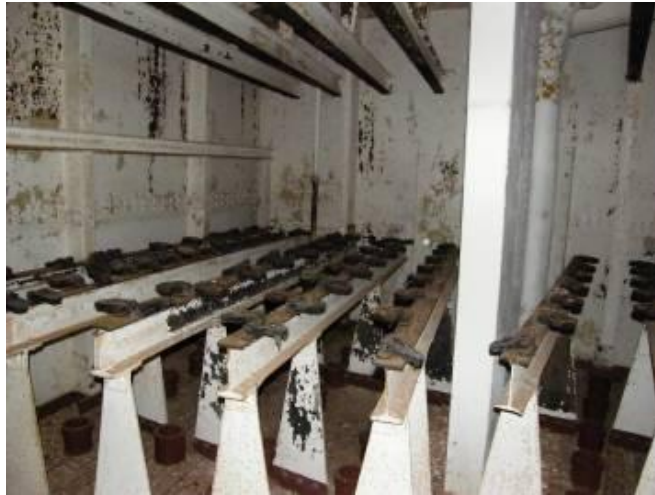
**Figure 264 14" Shell Magazine (A – 51 MP; Port)**

This space is in good structural and fair cosmetic condition.

**Prepare, prime and paint space.**

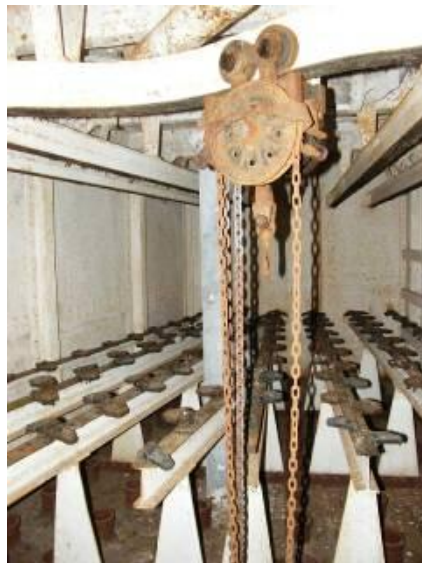
**Figure 265 14" Shell Magazine (A – 51 MS; Starboard)**

This space is in good structural and fair cosmetic condition.

**Prepare, prime and paint space.**

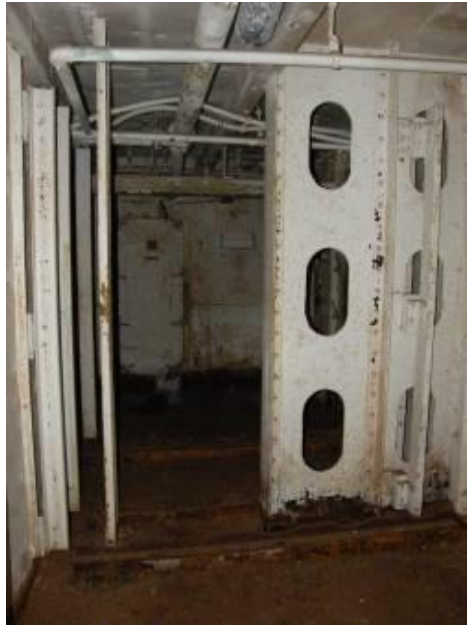
**Figure 266 14" Powder Magazine (A – 52M; Centerline)**

This space is in good structural and fair cosmetic condition.

**Prepare, prime and paint space.**

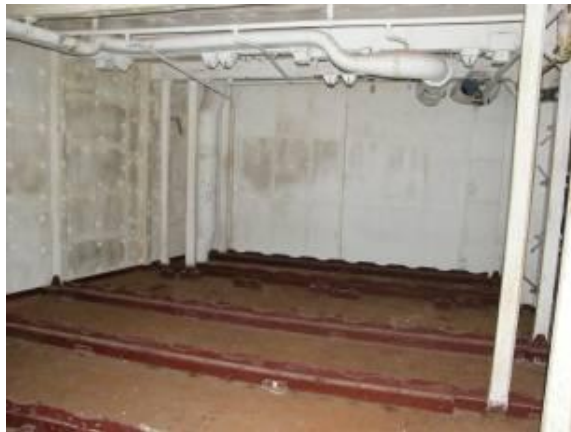
**Figure 267 14" Powder Magazine (A – 54 MP; Port)**

This space is in good structural and fair cosmetic condition.

**Prepare, prime and paint space.**

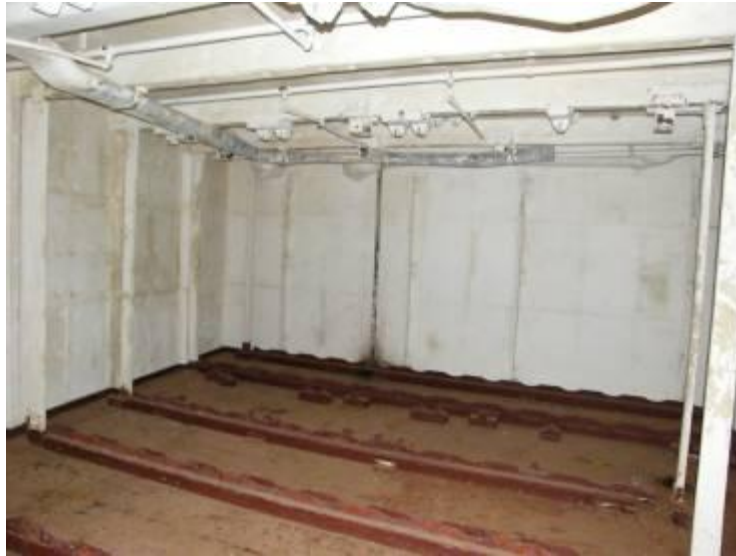
**Figure 268 14" Powder Magazine (A – 54 MS)**

This space is in good structural and fair cosmetic condition.

**Prepare, prime and paint space.**

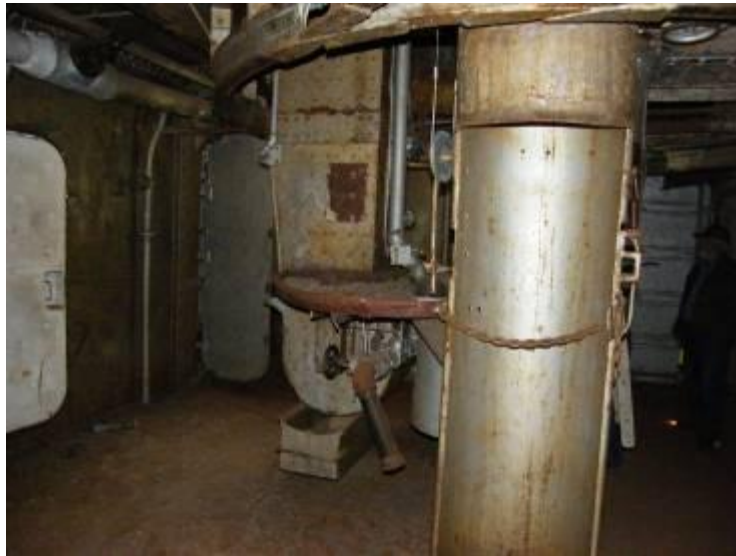
**Figure 269 14" Handling Room (A – 56; Centerline)**

This space is in good structural and fair cosmetic condition

**Prepare, prime and paint space.**

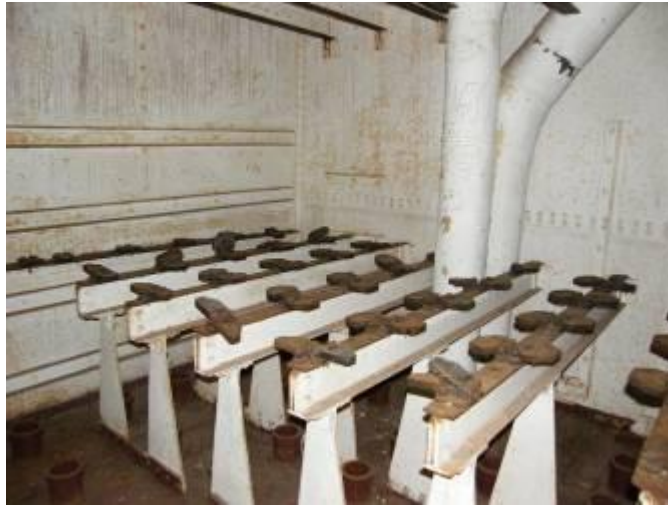
**Figure 270 14" Shell Magazine (A – 57 MP; Port)**

This space is in good structural and fair cosmetic condition.

<b>Prepare, prime and paint space.</b>
--

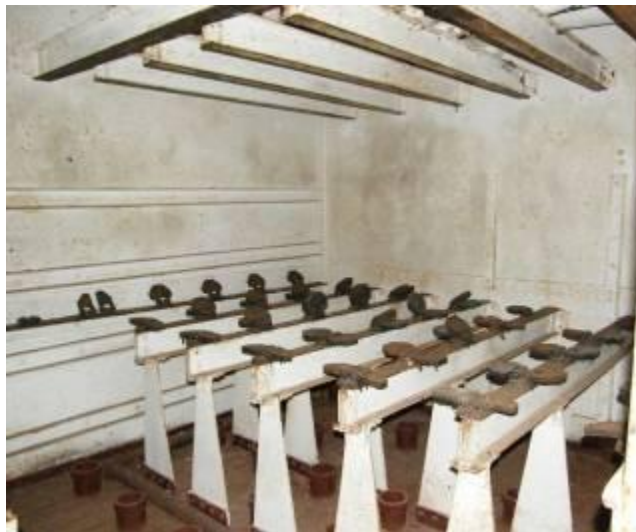
**Figure 271 14" Shell Magazine (A – 57 MS; Starboard)**

This space is in good structural and fair cosmetic condition.

<b>Prepare, prime and paint space.</b>
--

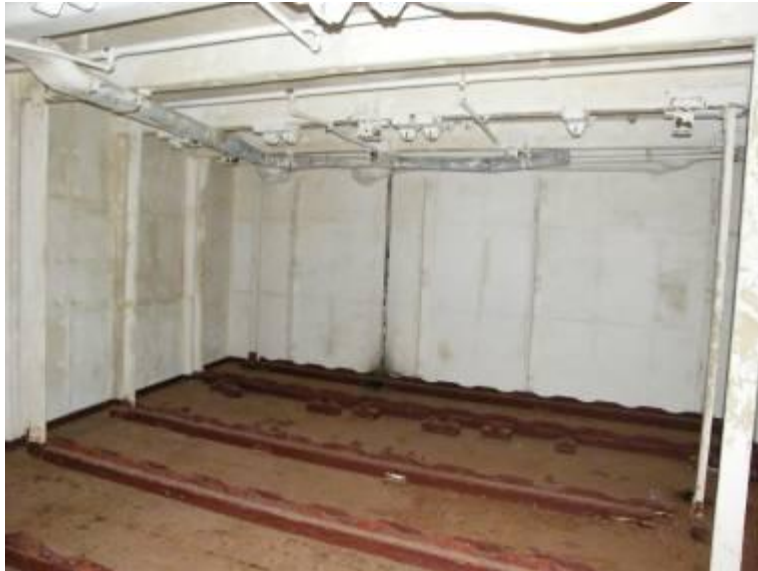
**Figure 272 14" Powder Room (A – 58 MP; Port)**

This space is in good structural and fair cosmetic condition.

**Prepare, prime and paint space.**

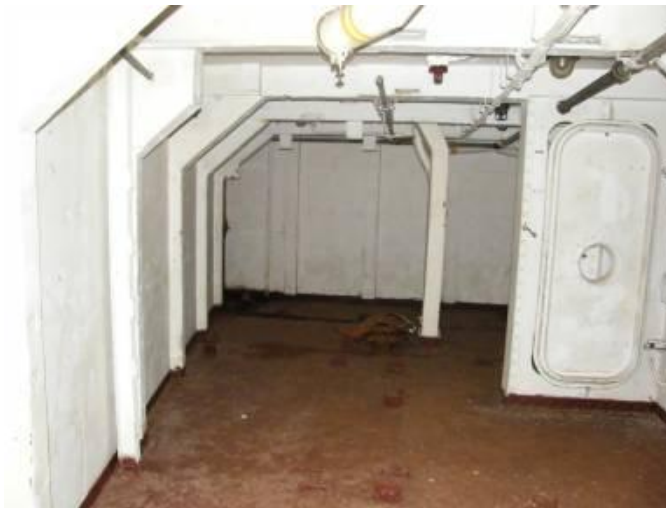
**Figure 273 14" Powder Room (A – 58 MS; Starboard)**

This space is in good structural and fair cosmetic condition.

**Prepare, prime and paint space.**

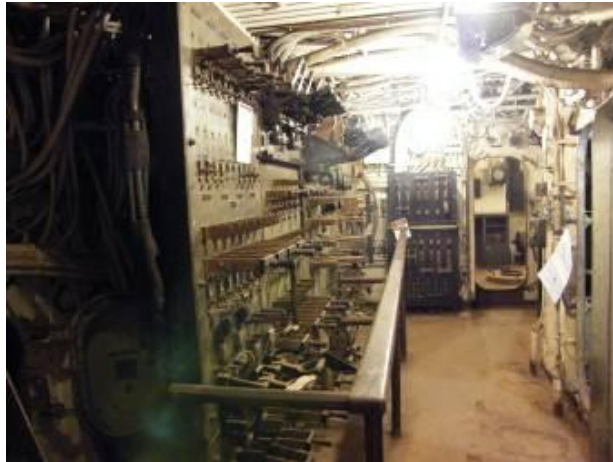
**Figure 274 Distribution Room (A-60; Centerline)**

This space is in good structural and fair cosmetic condition.

**Prepare, prime and paint space.**

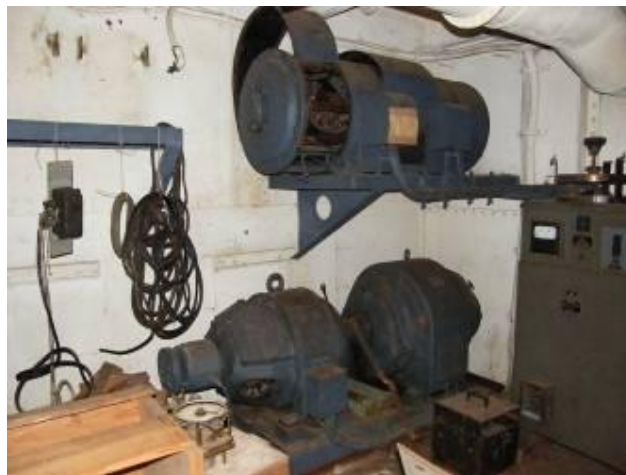
**Figure 275 Motor Generator Room (A – 61S; Starboard)**

This space is in good structural and fair cosmetic condition.

**Prepare, prime and paint space.**

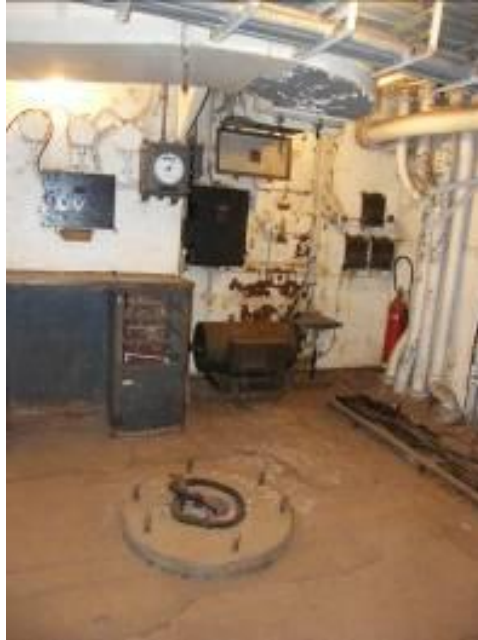
**Figure 276 Forward Gyro Room (A – 61P; Port)**

This space is in good structural and fair cosmetic condition. Gyro is missing.

<p><b>Prepare, prime and paint space.</b></p>
---

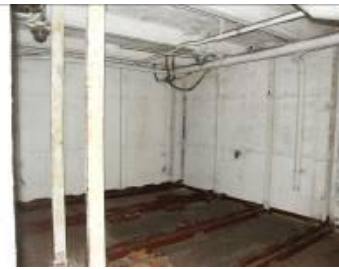
**Figure 278 14" Powder Room (C-35 M-S; Starboard)**

This space is in good structural and fair cosmetic condition. Cosmoline has been painted on powder chutes.

**Prepare, prime and paint space.**

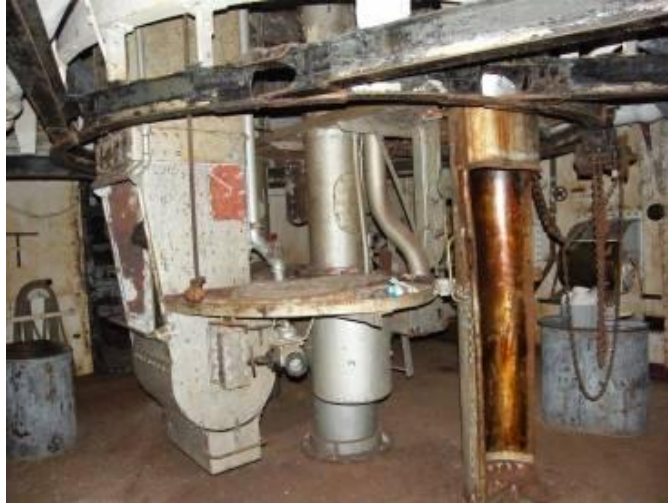
**Figure 280 14" Handling Room (C-36; Centerline)**

This space is in good structural and fair cosmetic condition. Cosmoline has been painted on powder chutes.

**Prepare, prime and paint space.**

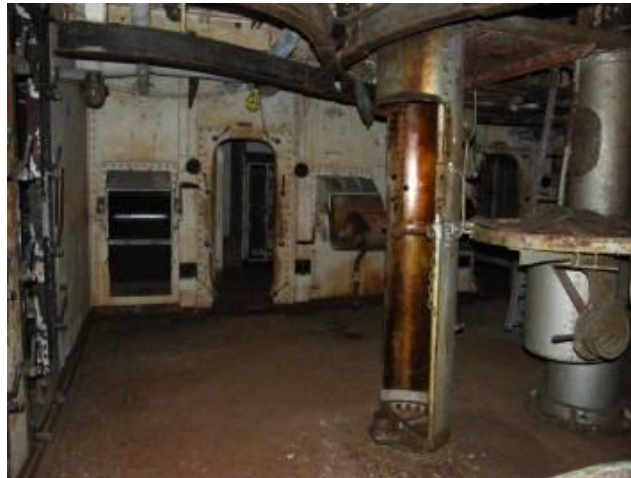
**Figure 281 14" Handling Room (C-37; Centerline)**

This space is in good structural and fair cosmetic condition. Cosmoline has been painted on powder chutes.

**Prepare, prime and paint space.**

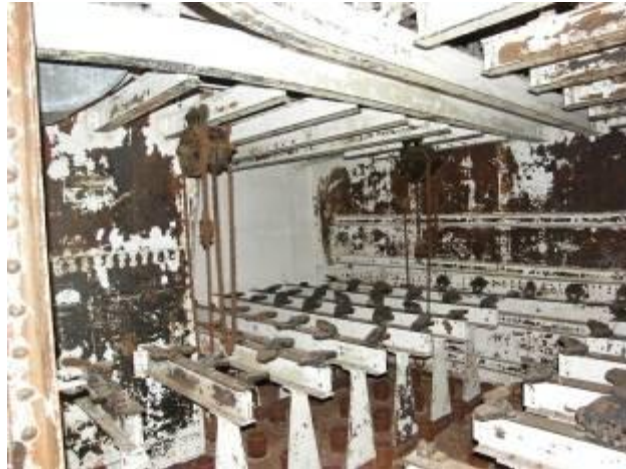
**Figure 282 14" Shell Magazine (C-38-M-P; Port)**

This space is in good structural and fair cosmetic condition.

**Prepare, prime and paint space.**

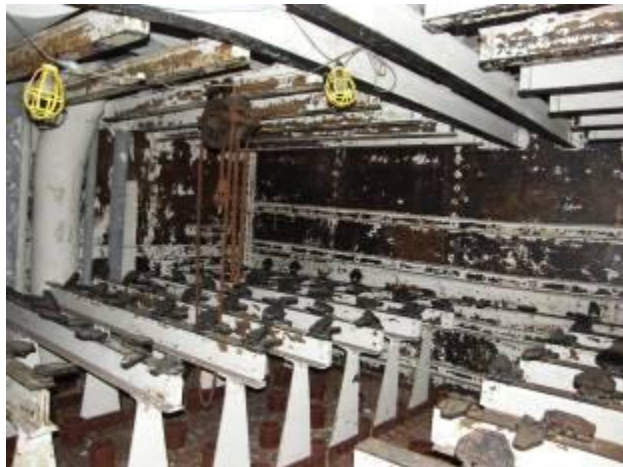
**Figure 283 14" Shell Magazine (C-38 M-S; Starboard)**

This space is in good structural and fair cosmetic condition

**Prepare, prime and paint space.**

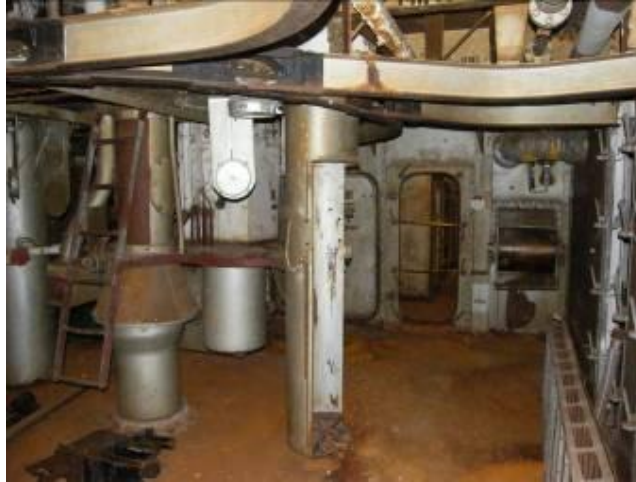
**Figure 284 14" Handling Room (D-29; Centerline)**

This space is in good structural and fair cosmetic condition.

<b>Prepare, prime and paint space.</b>
--

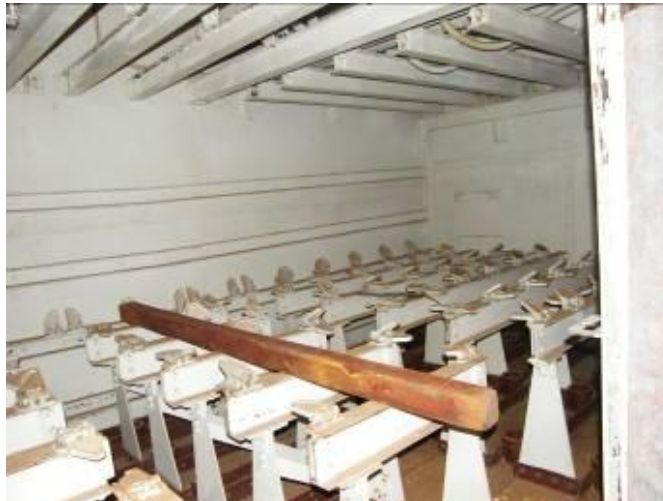
**Figure 285 14" Shell Magazine (D-30-M-S; Starboard)**

This space is in good structural and fair cosmetic condition.

<b>Prepare, prime and paint space.</b>
--

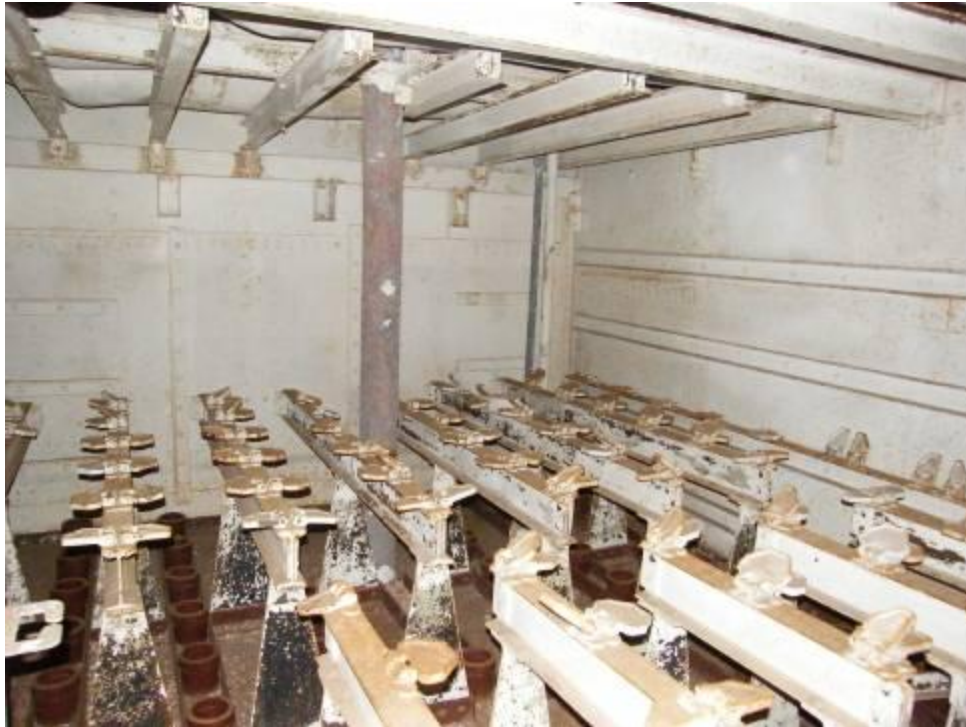
**Figure 286 14" Shell Magazine (D-30-M-P; Port)**

This space is in good structural and fair cosmetic condition.

<b>Prepare, prime and paint space.</b>
--

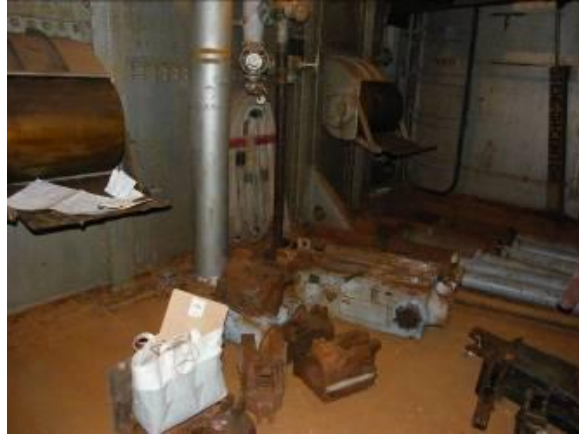
**Figure 287 14" Handling Room (D-32; Centerline)**

This space is in fair/good structural and fair cosmetic condition. The deck is holed on the starboard side aft adjacent to dogging hatch.

**Repair/replace thin deck adjacent to aft bulkhead and dogging hatch.**

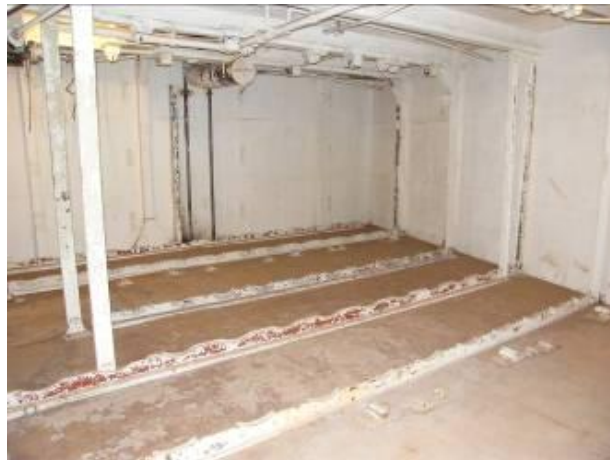
**Figure 288 14" Powder Magazine (D-34-M-S; Starboard)**

This space is in good structural and fair cosmetic condition

**Prepare, prime and paint space.**

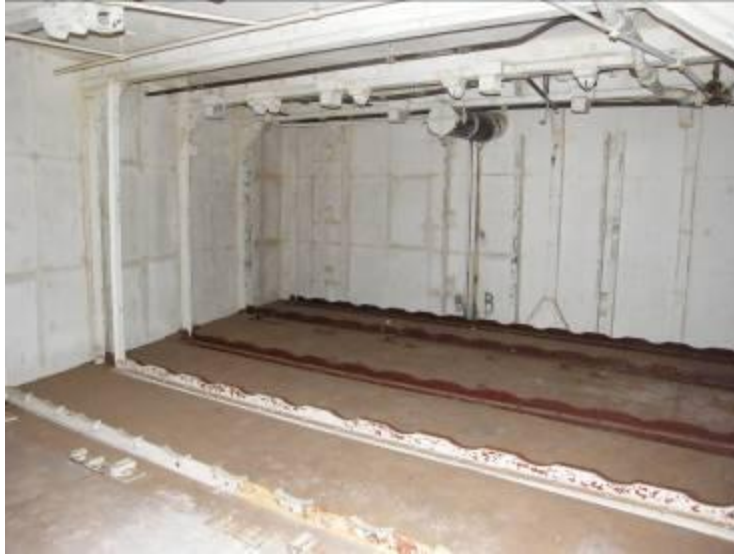
**Figure 289 14" Powder Magazine Room (D-34-M-P; Port)**

This space is in good structural and fair cosmetic condition.

**Prepare, prime and paint space.**

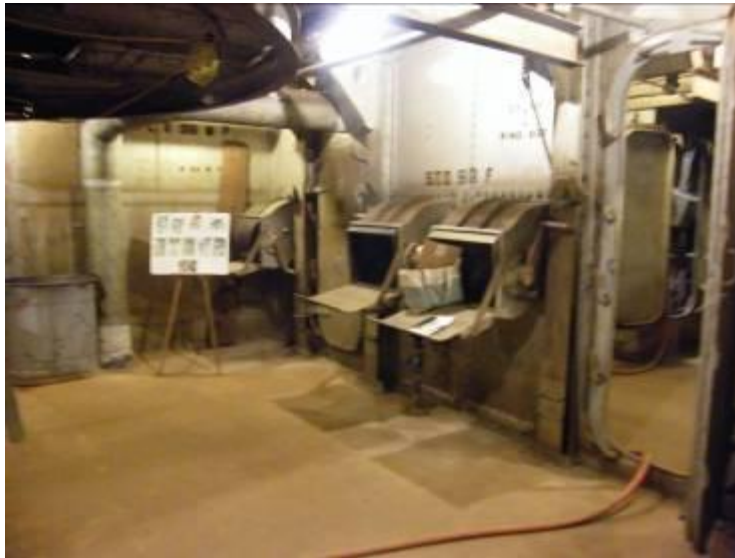
**Figure 290 14" Handling Room (D-35; Centerline)**

This space is in good structural and fair cosmetic condition.

**Prepare, prime and paint space.**

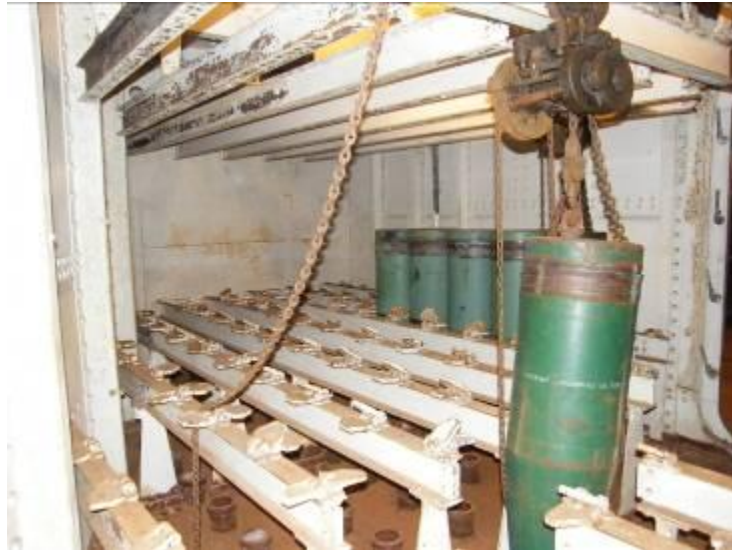
**Figure 291 14" Shell Magazine (D-36-M-S; Starboard)**

This space is in good structural and fair cosmetic condition.

**Prepare, prime and paint space.**

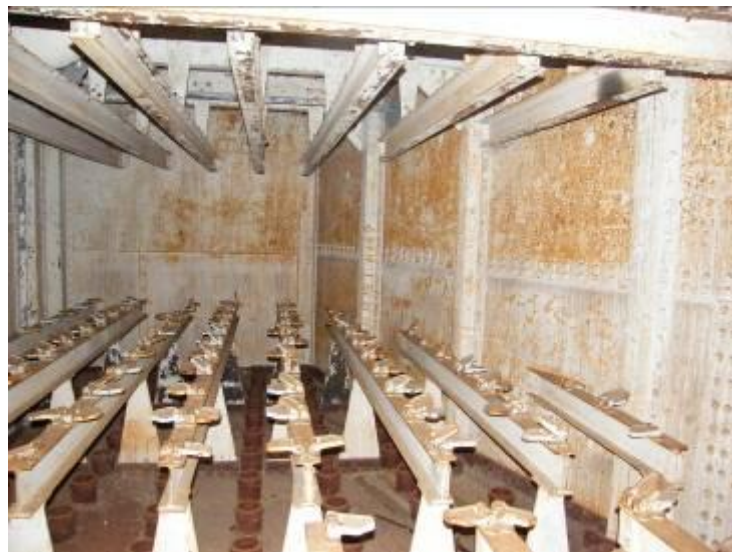
12.2.19 14" SHELL MAGAZINE (D-36-M-P, PORT)

This space is in good structural and fair cosmetic condition.

**Prepare, prime and paint space.**

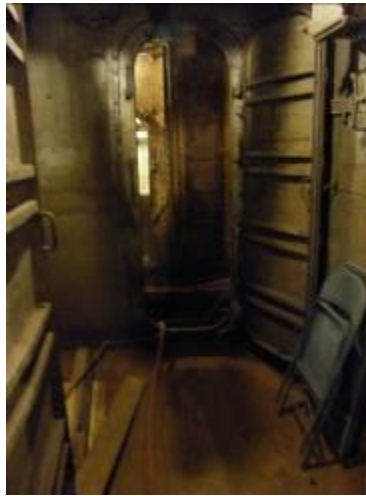
Figure 292 Passageway (D-38; Centerline)

This space is in poor structural and fair cosmetic condition. Entire deck is holed and badly corroded.

**Repair deck as needed.**

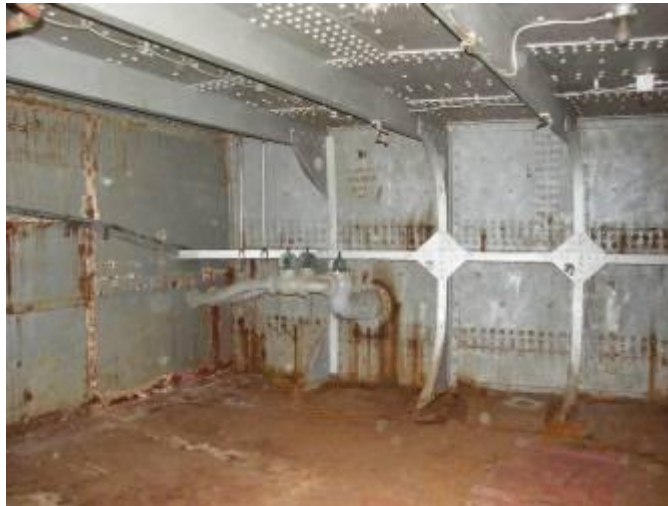
Figure 295 C&R Stores (C - 27; Frames No. 9 – 14)

This space is in fair structural and fair cosmetic condition. The entire deck is holed and badly corroded.

**Repair deck as needed.**
